# OVERCOMING THE HEAT TO DETECT FIVE LEAK PATHS

Fli identifies five leak paths in two high temperature suspended gas wells ahead of scheduled P&A operations.

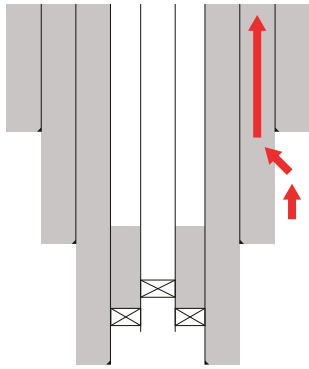
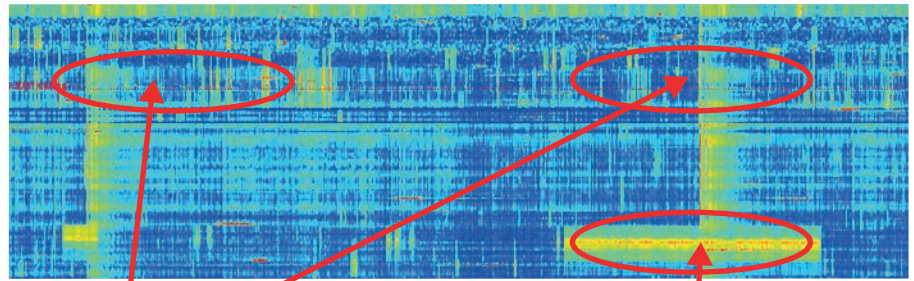
### Leak path 1

Events centred at SC shoe indicate flow

Fluid movement past formation shortly after SC bleed off

- Fibre was deployed to depth through the production tubing.
- Sequential annulus pressure manipulation:
- Surface casing (SC) pressure of 123 PSI bled off.
- Intermediate casing (IC) pressure of 587 PSI bled off.
- Production casing (PC) pressure of 325 PSI bled off.
- Tubing pressure of 168 PSI bled off.
- Fli identified three leak paths in this well: a) Below the SC shoe from the formation; b) Below the IC shoe from the formation; c) Through the PC from below the depth of the Fli probe.
- Surface casing and intermediate casing pressures are indicated to be reservoir fed.
- Production casing and tubing pressure is via a leaking packer and annular cement plug.
- A tubing leak was detected at 906m with no other indications of leaking tubing or casing.
- The tubing bridge plug is holding.

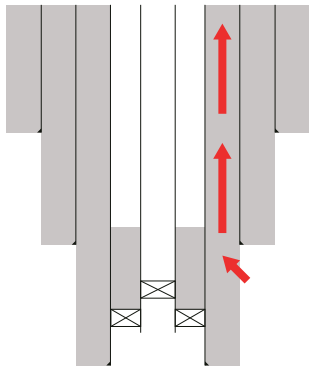
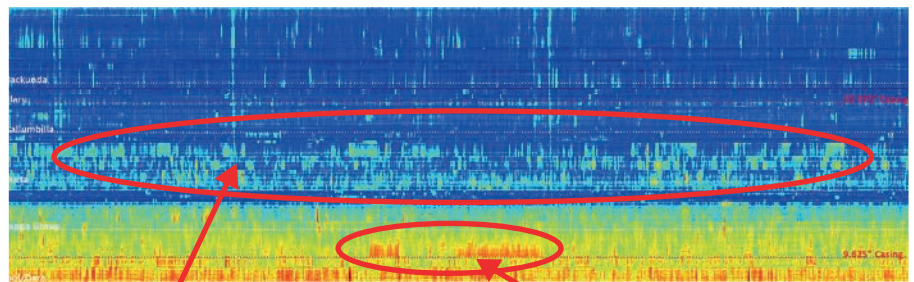
### Leak path 2

Signal from tortuous flow path above IC shoe

Activity at the IC shoe indicates leak entry point

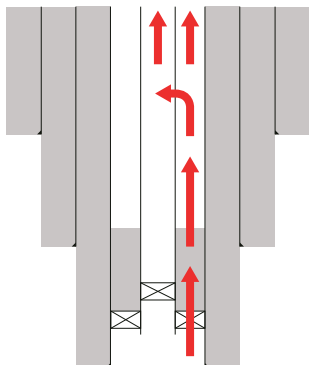
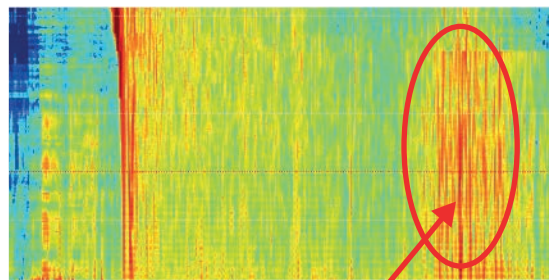
### Leak path 3

Leak through PC from below fibre depth shortly after PC bleed off

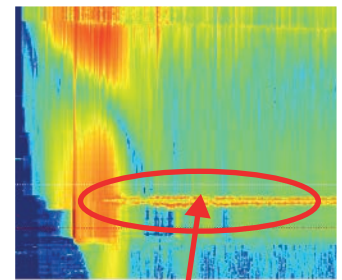
Tubing leak at 906m

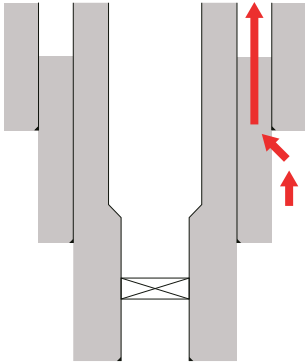
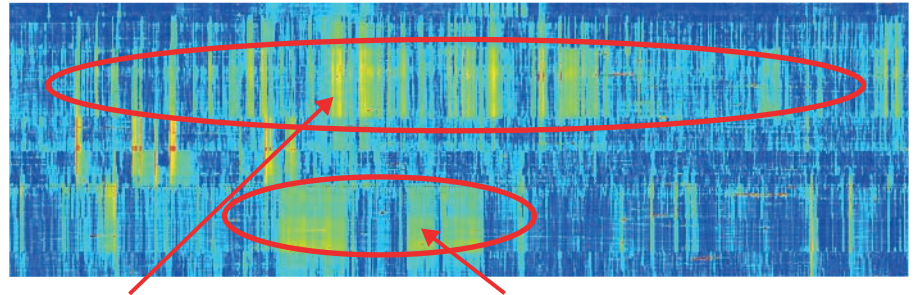
### Leak path 1

Signal indicating flow through cement channels above SC shoe

Signal indicating flow past formation below SC shoe shortly after SC bleed off

- Fibre was deployed to depth through the production casing as the tubing had already been removed.
- SC pressure of 24 PSI was bled off.
- PC pressure of 95 PSI was bled off.
- Fli data identified two leak paths: a) A flow past the formation below the SC shoe and through cement channels above the SC shoe; b) From the formation upwards through the PC plugs.
- SC pressure was indicated to be reservoir fed via cement.
- Production casing plugs are leaking.
- No evidence of leaking tubulars.

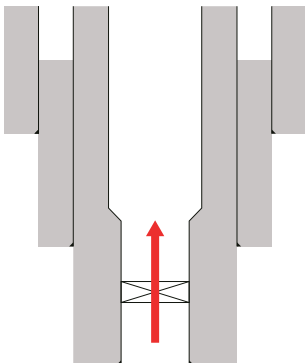
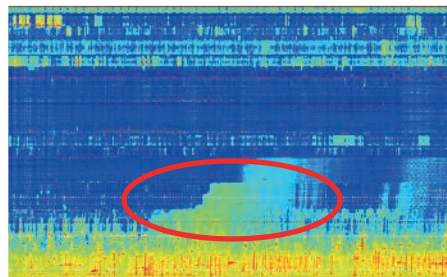
### Leak path 2

Signal from logging depth showing upwards pressure plume through PC plugs

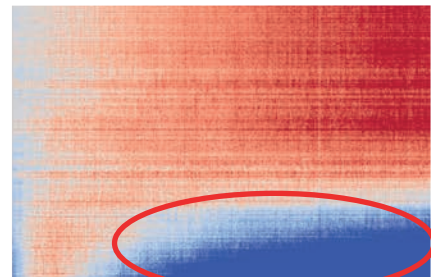
Cooling effect above PC plugs due to gas leak entry point expanding as it passes through plug leak path
